QUARTERLY PROJECT UPDATE REPORT 4th QUARTER 2019

**HARLTAND 36 GAS PLANT
PORTION OF E¹/₂ of NW ¹/₄ of SECTION 36, T03N-R06E,
HARTLAND TWP, LIVINGSTON COUNTY, MICHIGAN**

**LAMBDA ENERGY RESOURCES, LLC
1510 THOMAS ROAD
KALKASKA, MICHIGAN 49646**

ECT No. 130685-2000

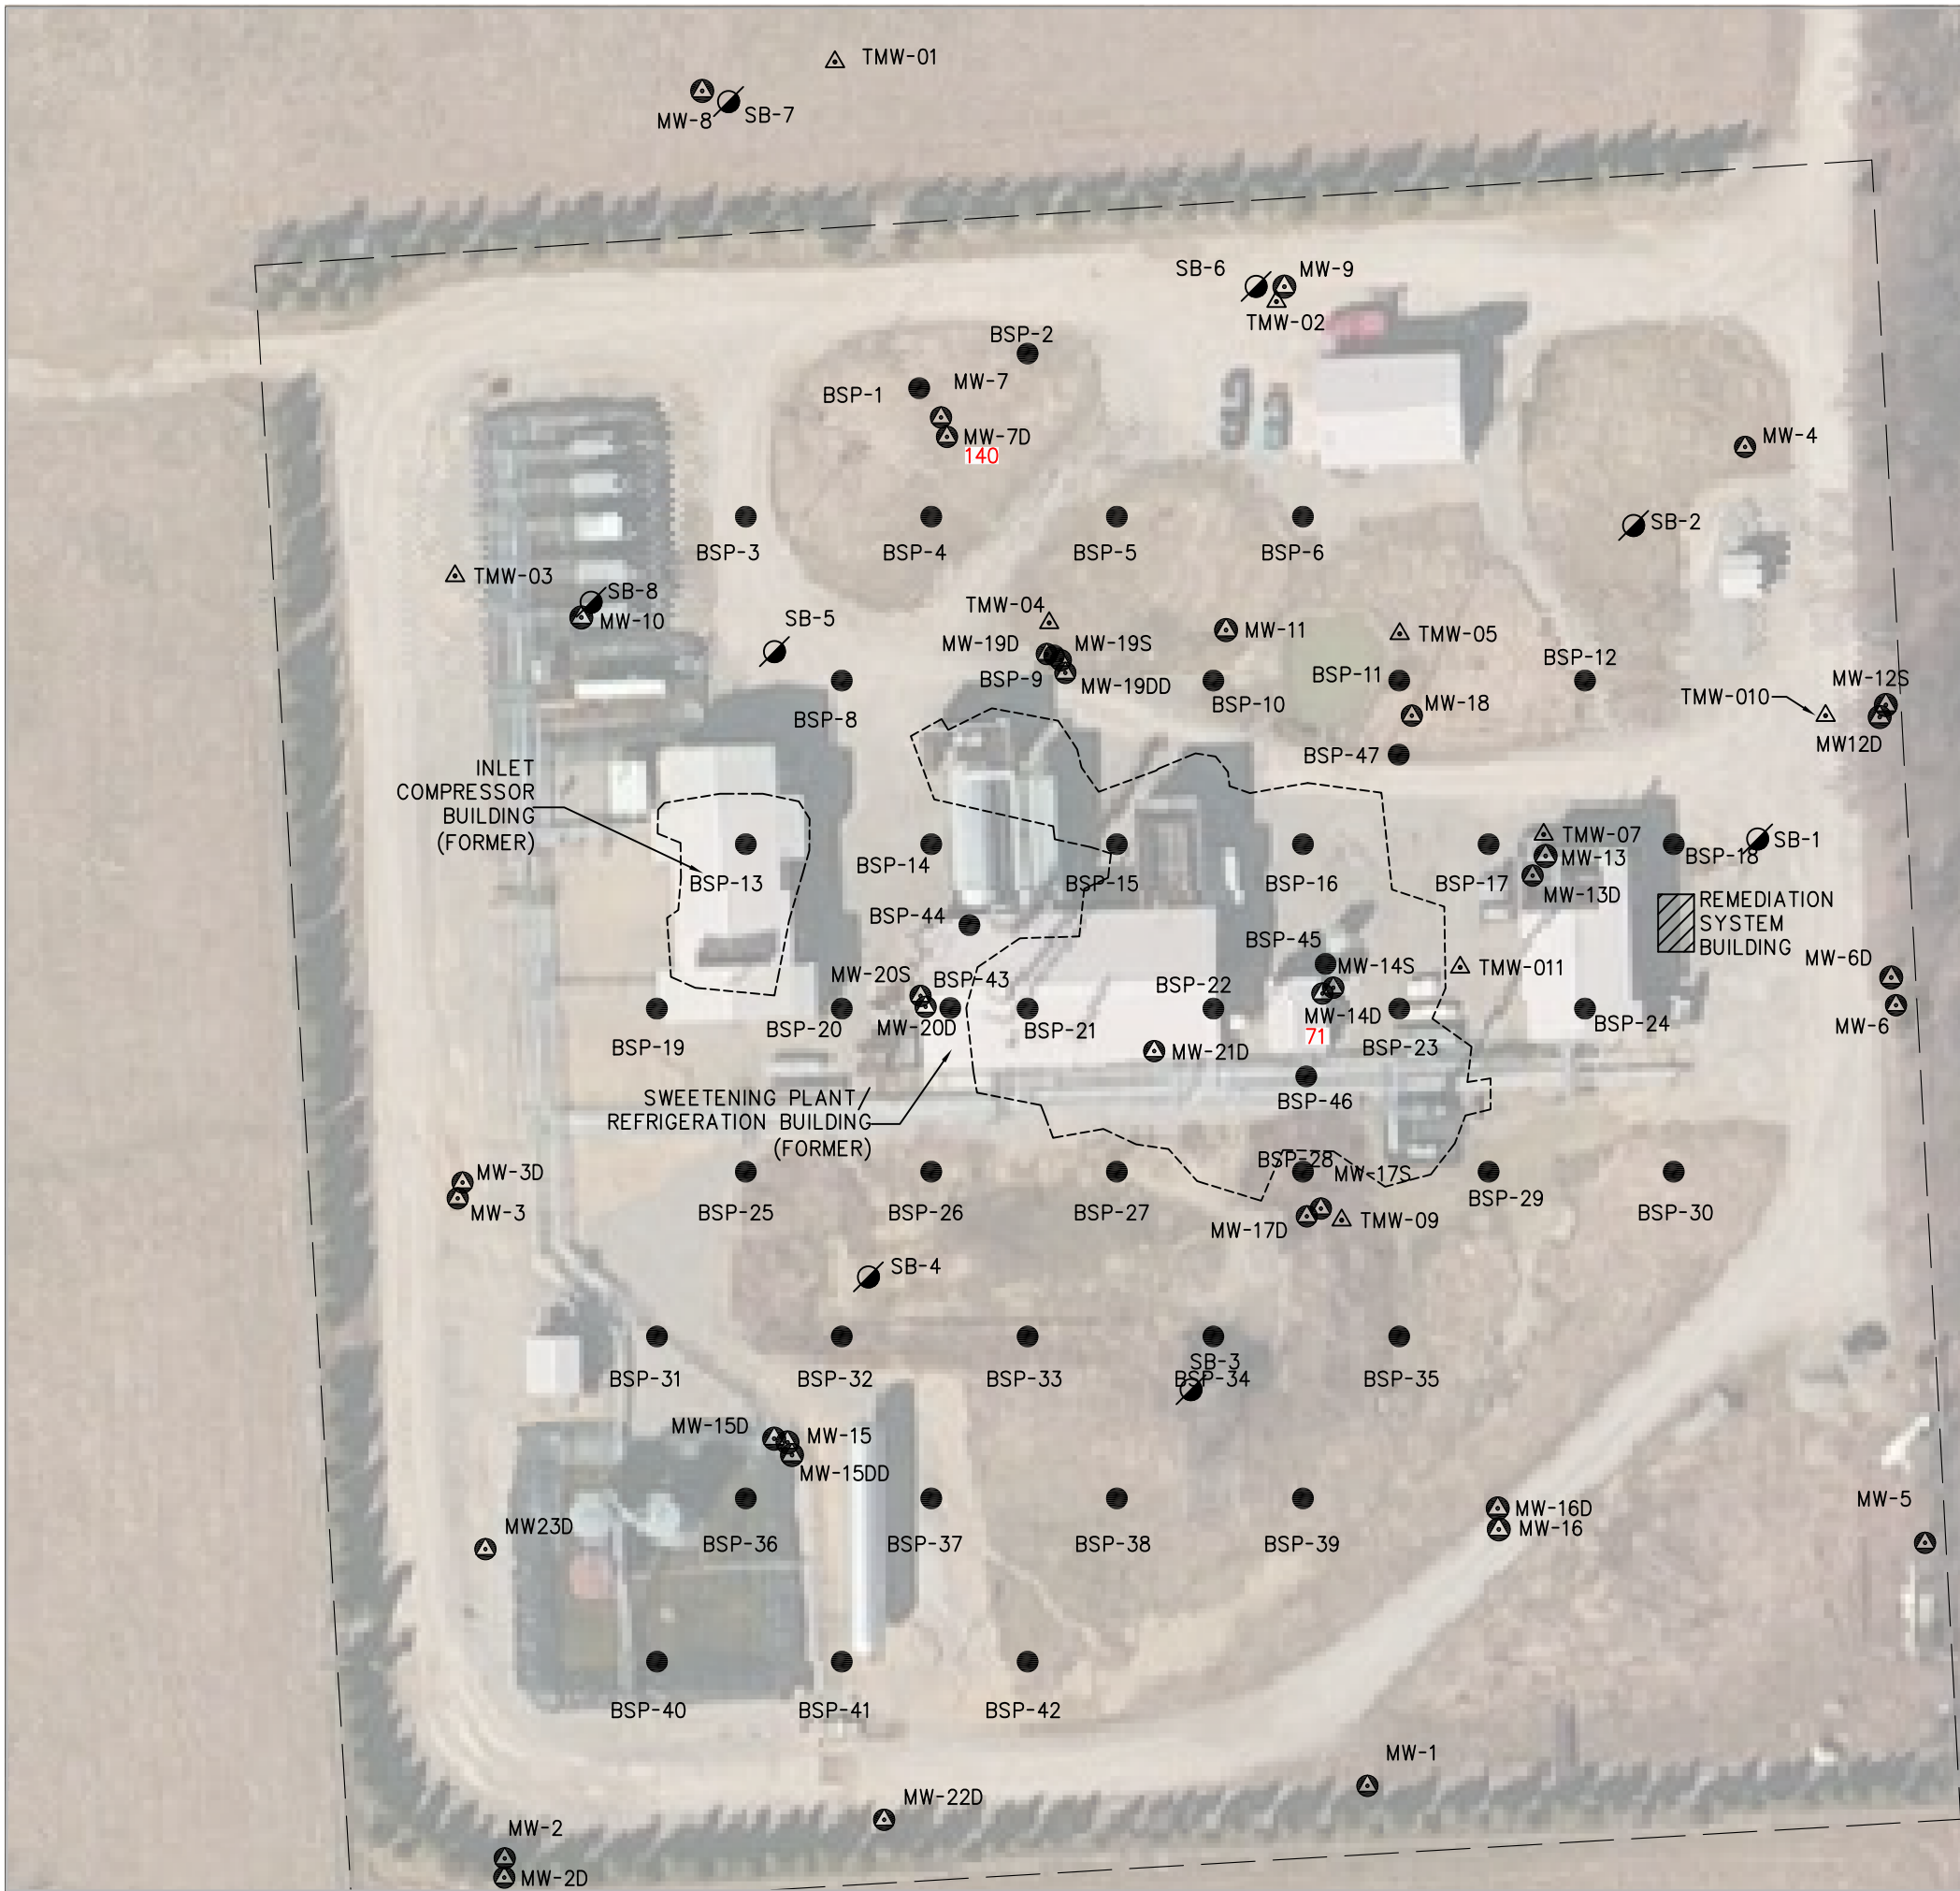
Please refer to Table 2 and Table 3 in Appendix B for a summary of groundwater monitoring data for the Site. Monitor well locations are illustrated on Figure 3 in Appendix A.

September 2019 Sulfolane Results (ug/L)
 Monitor wells with no results shown indicate results were "Not Detected at the Reporting Limit" or samples were not collected.

SITE PLAN
